A DETAILED ASSESSMENT OF THE INNOVATIVE METHOD FOR LARGE DIAMETER SEWER INSPECTION TO DETERMINE STRUCTURAL INTEGRITY

Francieli Thums, B.Eng Civil and Environmental Engineer. Wessex Water, Bath, UK.

Background: Braidley Rd tunnel

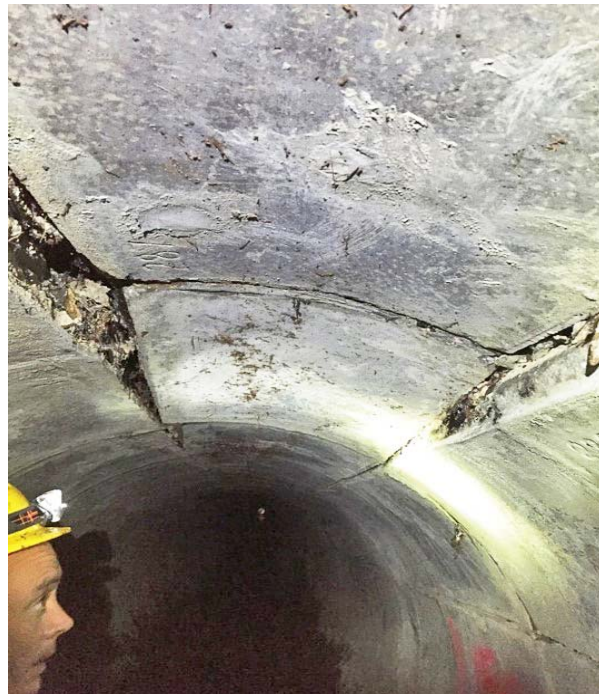
Figure 2. Defects found along the tunnel during person-entry survey.

At some point over the last few years, the Braidley Rd tunnel has been hydraulically surcharged and the water pressure has forced the segments out, over a 40m length, mid-way along the tunnel (Fig 2 &3). For the first time the MAC extensometer has given us the ability to understand the structural capability of the tunnel lining, which we assumed would vary along its 220m length, between shafts. By iteratively analysing the tunnel in discrete lengths, we were able to understand the potential longevity of the tunnel.

From the results obtained it was suggested to reline the entire length in order to protect against internal hydraulic surcharge.

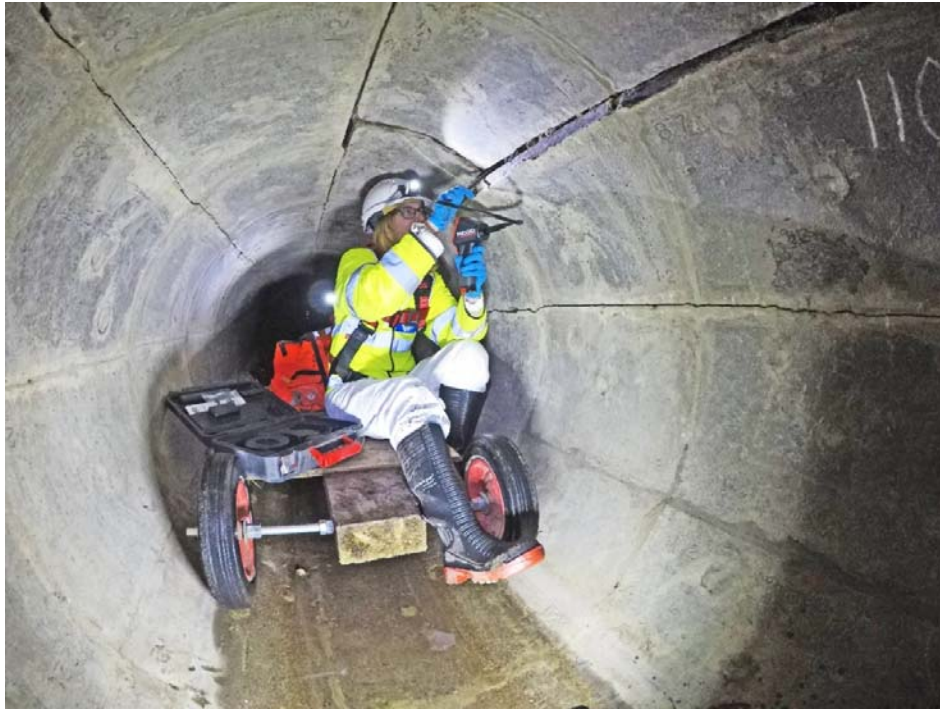
Figure 3. Inspection of open joints by endoscope, confirmed poor original back grouting.

One reason for this result can be related to the grouting outside the segments during construction. It may be that in this area more grouting material was needed to fill the annulus at or below the horizontal mid-level as confirmed by the use of the endoscope, which acted as very hard/stiff ground, therefore the stiffness of the pipe is influenced by the concrete elements and the grouting outside. Yet this was not evident in the crown of tunnel, as deformation is evident. Soil stiffness could not be calculated due to very different boundary conditions.

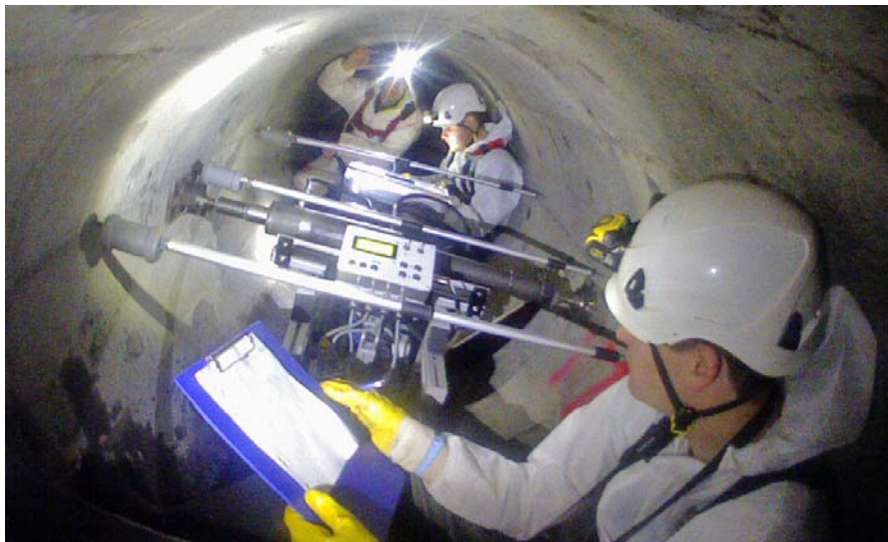
During the survey, the measuring plates were placed at a height of 600 mm from the bottom of the tunnel and measuring points were located at every five meters along the sewer length, resulting in twenty-one measuring points.

Figure 4. MAC test being carried out in the Braidley Tunnel.

At every point, 60 kN force was applied and readings were obtained of the deformation caused in the inner wall and a graph instantaneously produced the force–displacement curve across the pipe and the damping of the displacement in the longitudinal direction.

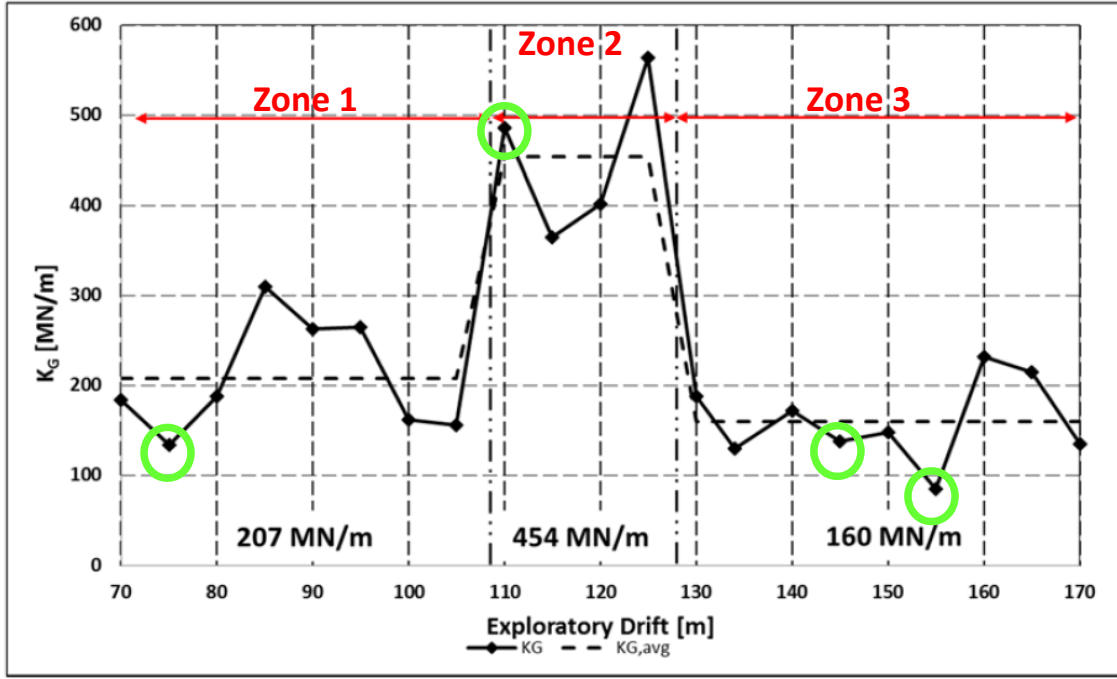
The 100m section of tunnel surveyed was divided into three zones based on the structure's behaviour (homogeneous Pipe-Soil Stiffness – K_G and the Damping-Ratio – Ω) as showed in Figure 5 and 6. Points highlighted in green represent the core samples location.

Figure 5. MAC graphical output.

It was identified that in the second zone, stiffness was higher than in the first and third zone, whilst the subsequent core tests proved an average UCS value of 67 N/mm², which is considered high; as structural concretes are normally around 40 N/mm².

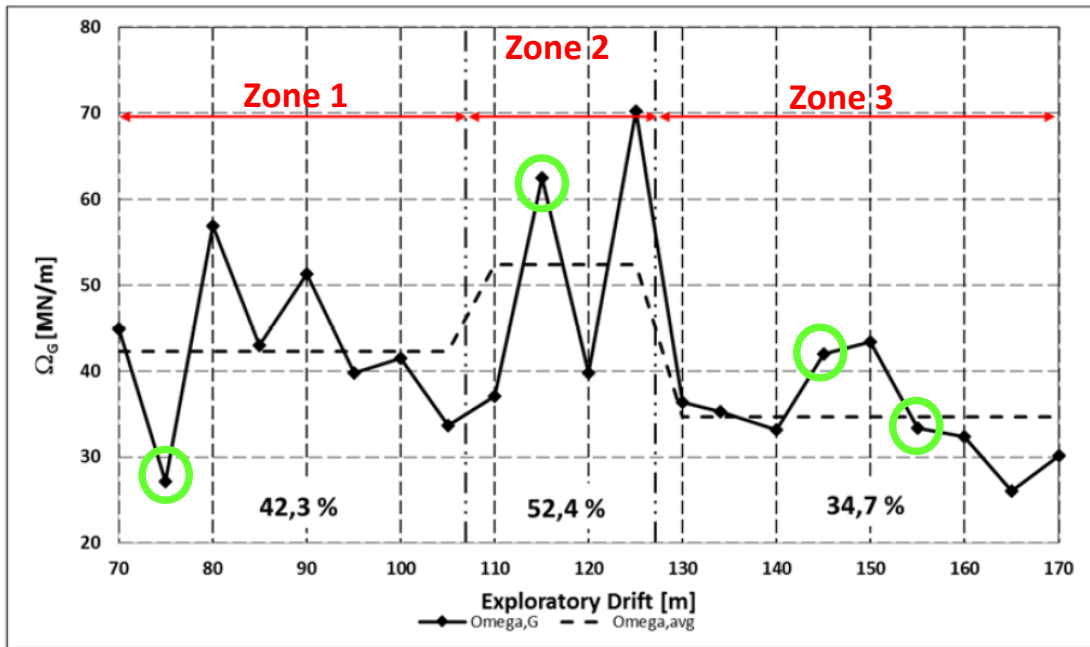
Figure 6. Damping ratio.

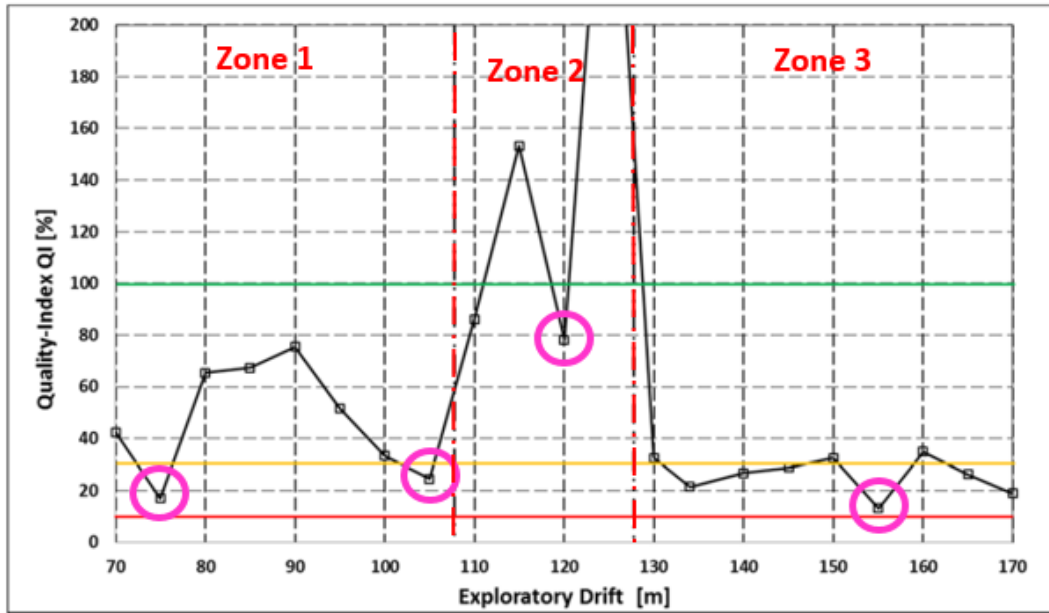
The stiffness of soil and sewer were divided into zones and static calculations were undertaken. The numerical FEM calculations are represented graphically in Figures 7 & 8. The points highlighted in pink in the graphs correspond to the most critical areas of the sewer due to the low stiffness calculated.

Figure 7. Quality index.

Predominantly the stiffness values in zones 1 and 3 were low, yet the lining was intact and looked visually competent, whilst zone 2, the known defective length, had a higher stiffness, with the exception of one measuring point, where soil stiffness is nearly zero.

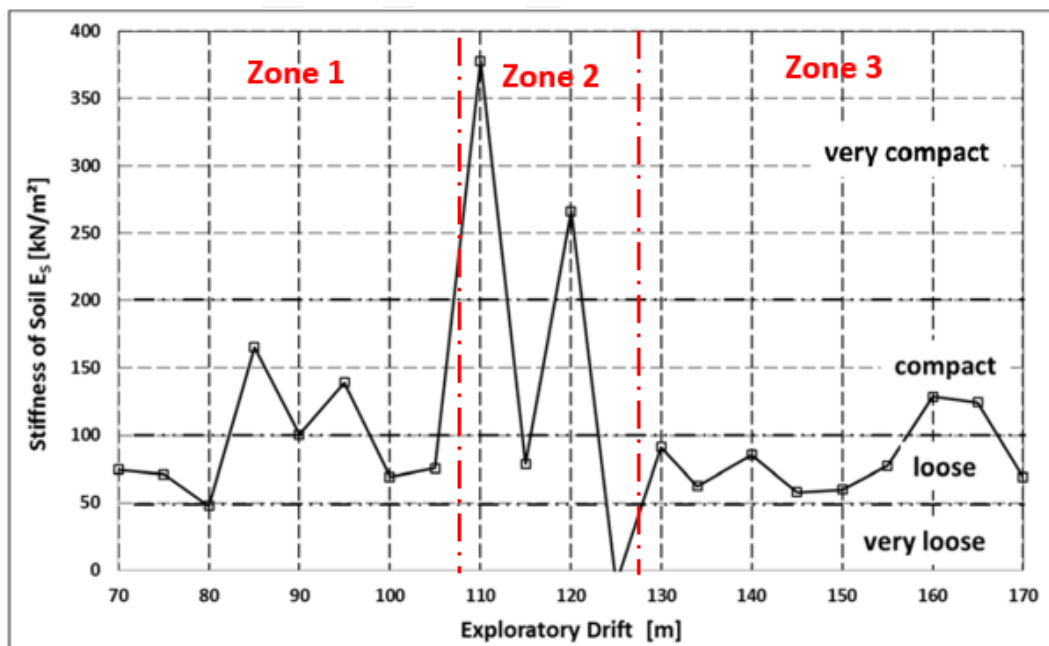
Figure 8. Stiffness of Soil.

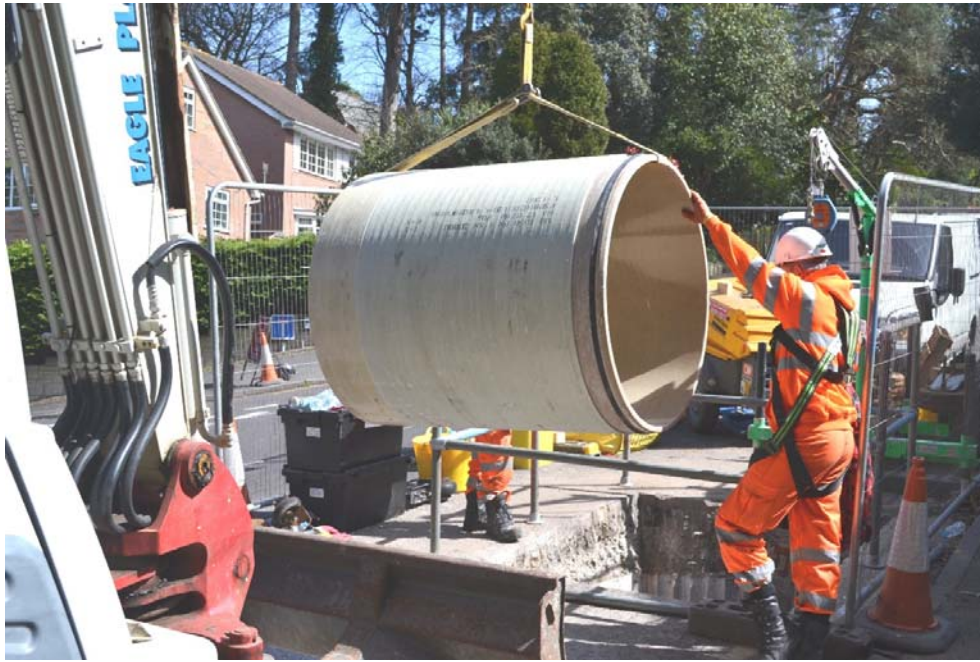
Figure 9. Amiantit SRM TYPE1 GRP linings imported from Poland.
