What Tool is the Best Tool?

Pipe Diagnostics

Tom Hives
Implementation Manager
Aquam Pipe Diagnostics

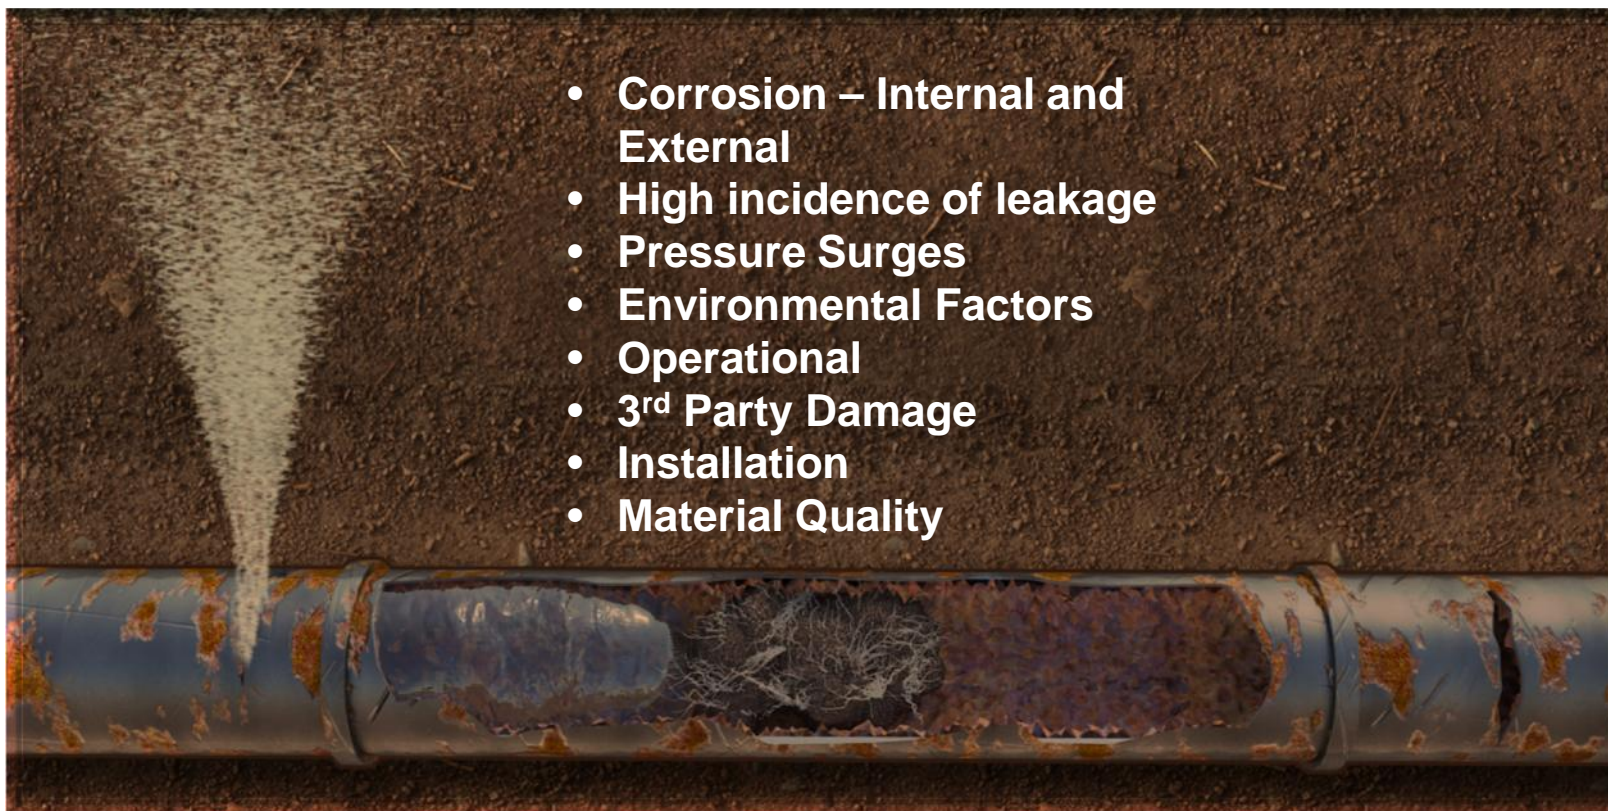
Common Causes of Pipeline Degradation

- Corrosion – Internal and External
- High incidence of leakage
- Pressure Surges
- Environmental Factors
- Operational
- 3rd Party Damage
- Installation
- Material Quality

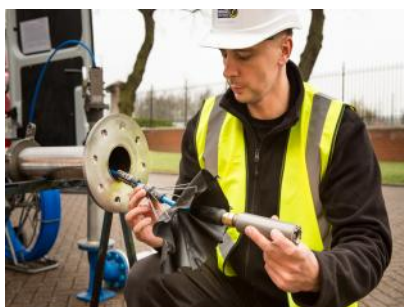
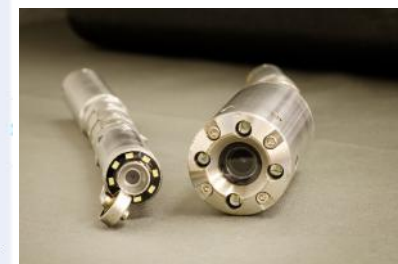
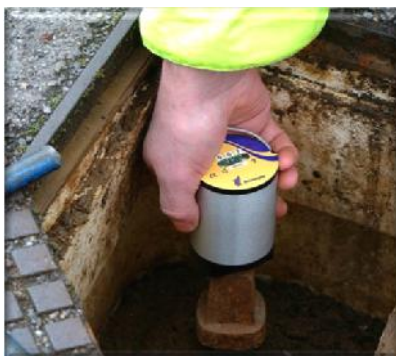
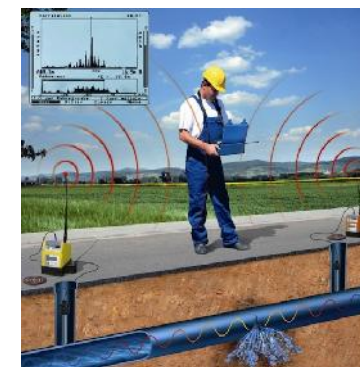
Pipeline Diagnostics Leak Detection

In Line Leak Detection		
Solutions	Applications	Benefits
<ul style="list-style-type: none"> • Tethered • Untethered 	<ul style="list-style-type: none"> • 3" and above • Transmission Mains • All Pipe Materials (providing pressure is adequate) • Complex Environments (urban, under railroads, highways, excessive noise) • Pressurized Inspections • Existing pressurized fittings, fire hydrants and hot taps • Low operational Pressure (15psi+) 	<ul style="list-style-type: none"> • No limitations due to pipe material • LD on high risk pipes = >ROI • Increased Accuracy – sensor is brought to actual leak location • Real Time – On site Results • Identification of air pockets • Untethered – long inspection distances • Minimalizes Collateral Damage • Positively impacts Real Water Losses • Screening tool for higher resolution condition assessment tools • No disruption to service
External Leak Detection		
Solutions	Applications	Benefits

<ul style="list-style-type: none"> • Loggers • Correlators • Ground Mics 	<ul style="list-style-type: none"> • Maximum pipe diameter 20" • Most effective on metallic pipe • Leak Localization • Abundance of access points • Limited Budget 	<ul style="list-style-type: none"> • Efficient 'on site' results • Increased response time for repair • Simple Installation • No disruption to service • Inexpensive screening tools • Prioritize where higher resolution tools need to be introduced • Positively impacts real water loss • Proactive approach when utilized as part of a water loss program

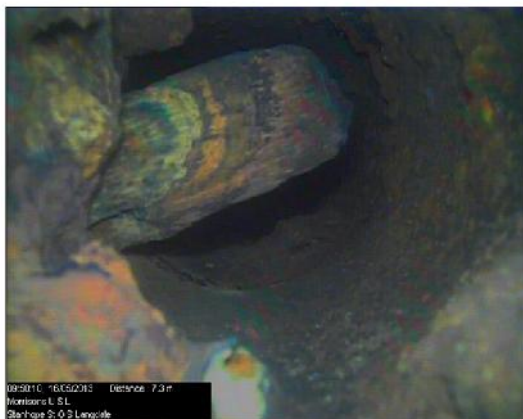
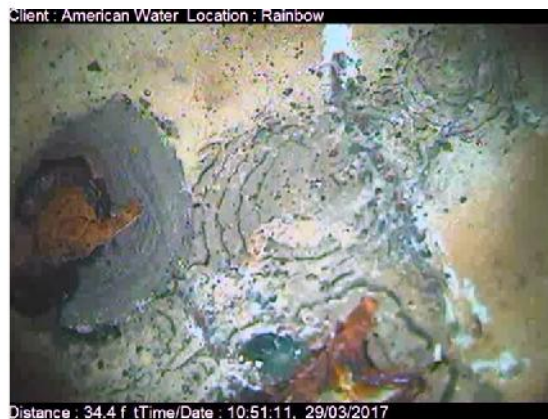
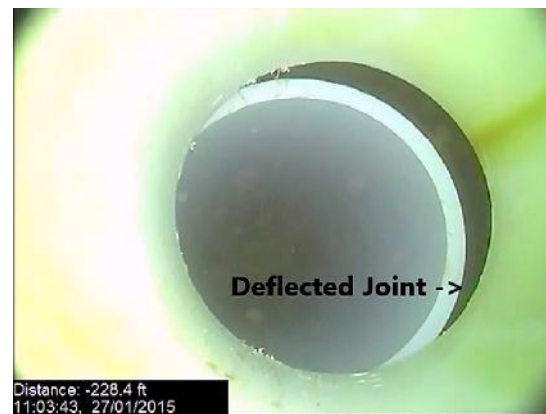
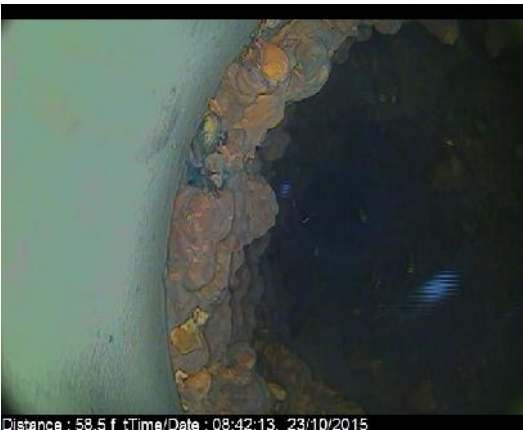
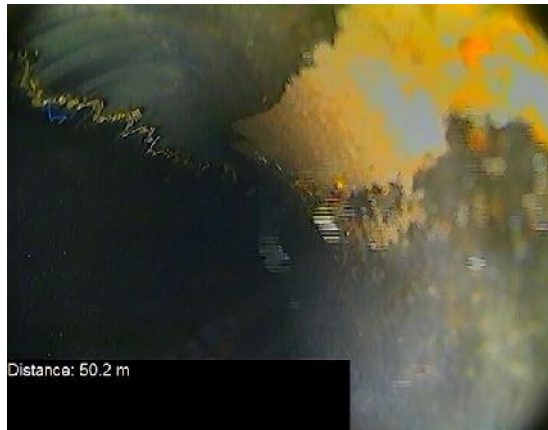
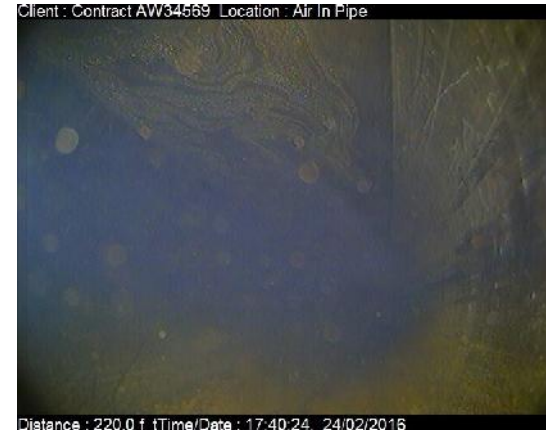
Pipe Diagnostics Visual Inspection

Obstructions

Illegal Connections

Fractures

Air Pockets

Sedimentation

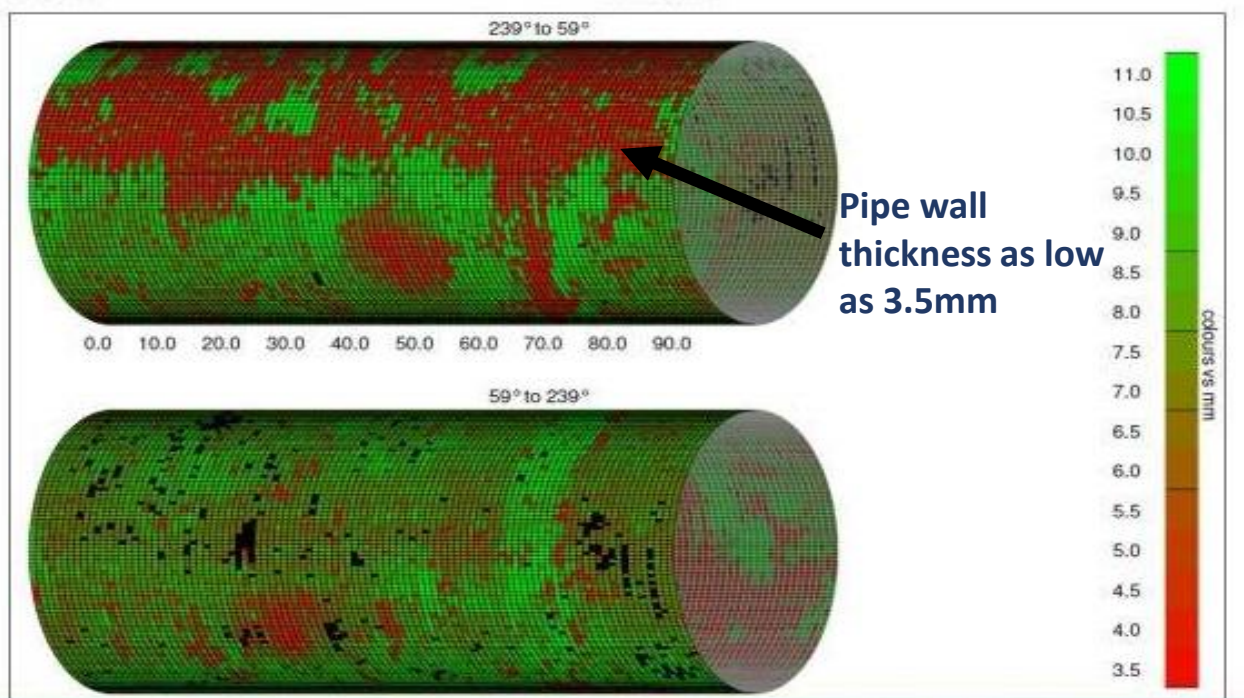
- NDT Pipe Wall Thickness
- Interior and Exterior corrosion
- Estimated Life Expectancy
- Risk Assessment

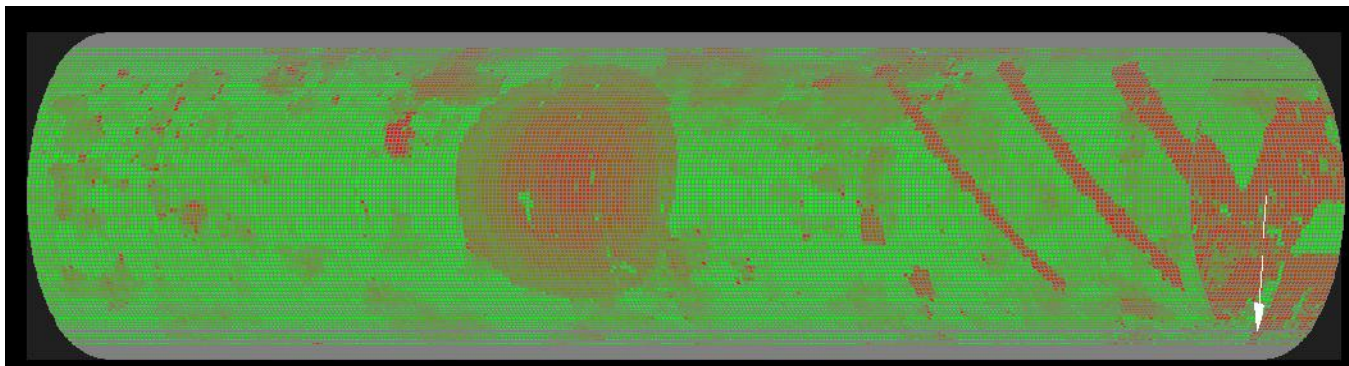
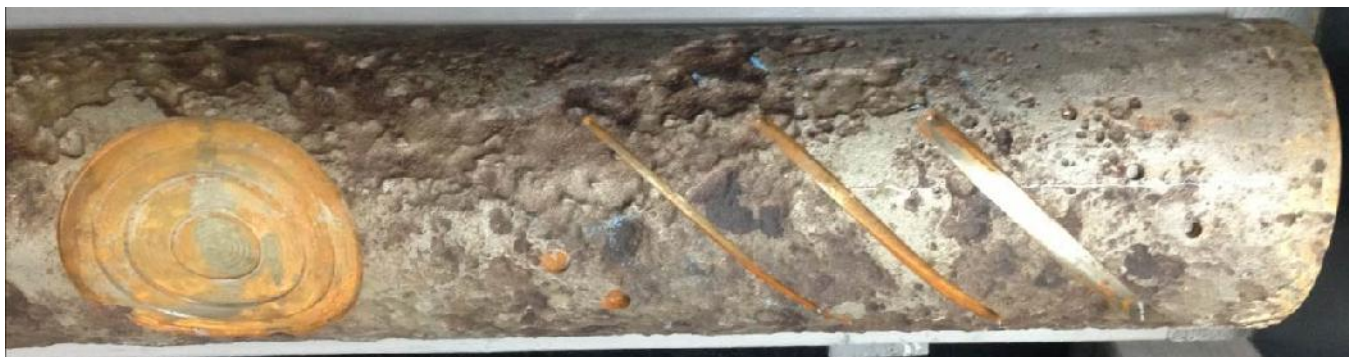
**Exhumed cast iron
pipe with
machined features**

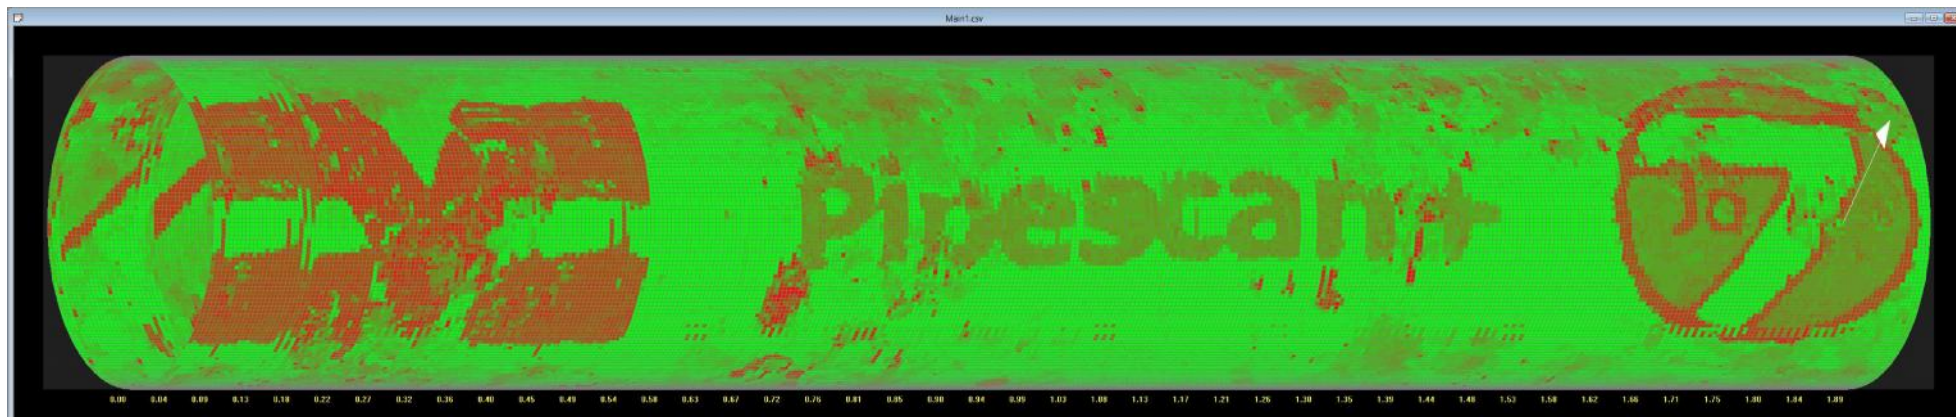
**Pipescan+ Ultrasonic Image of
Engraved Carbon Steel Pipe**

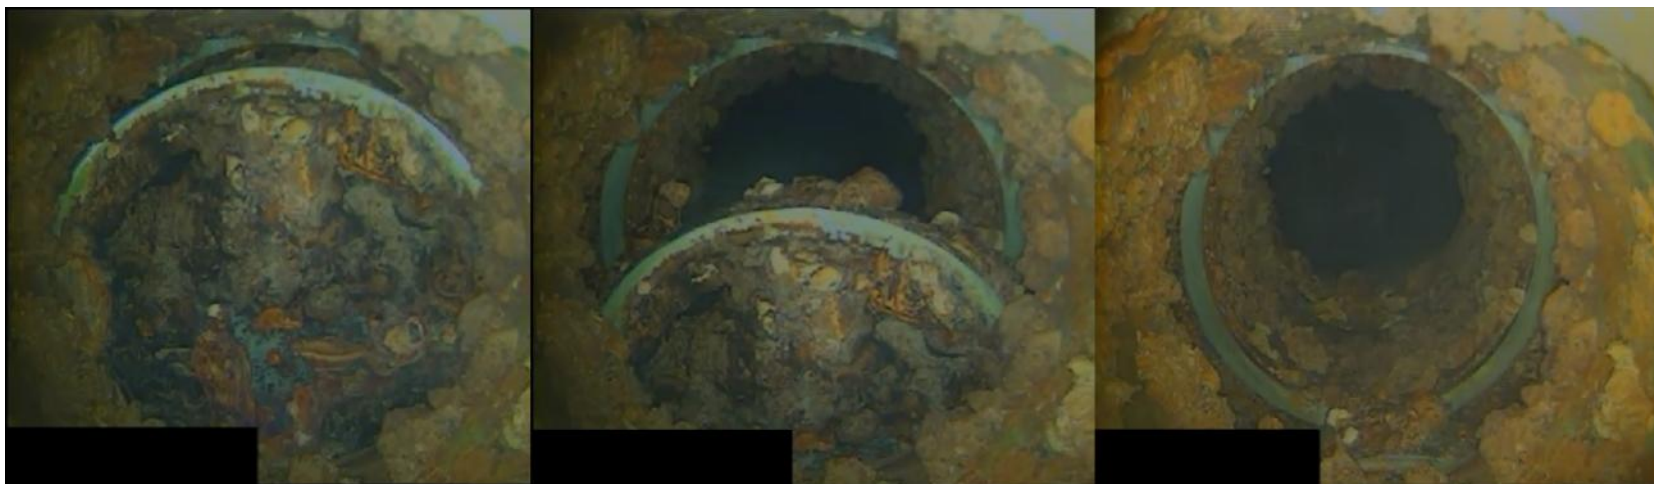
Valve Verification

Closed

Partially Open

Open

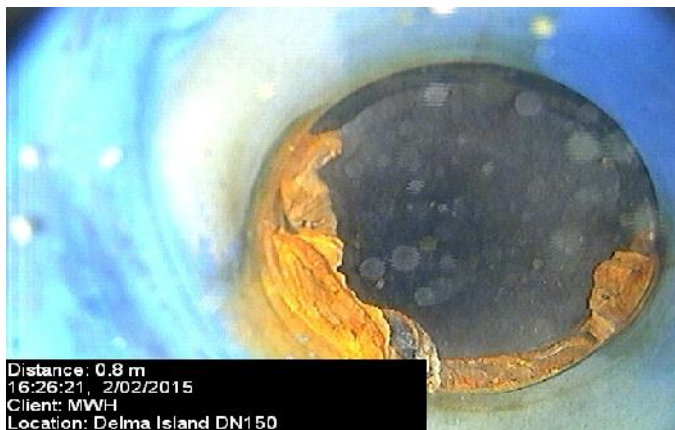
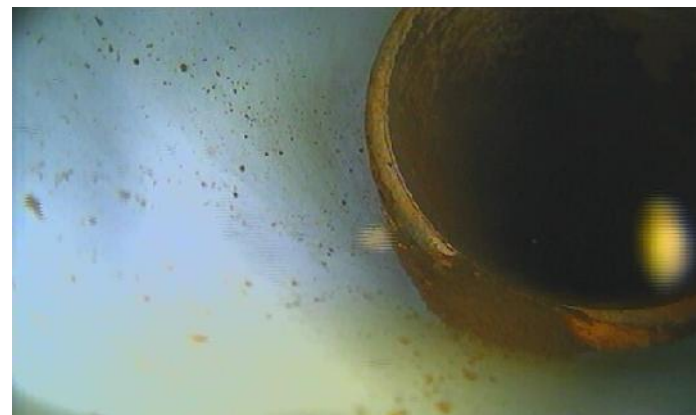
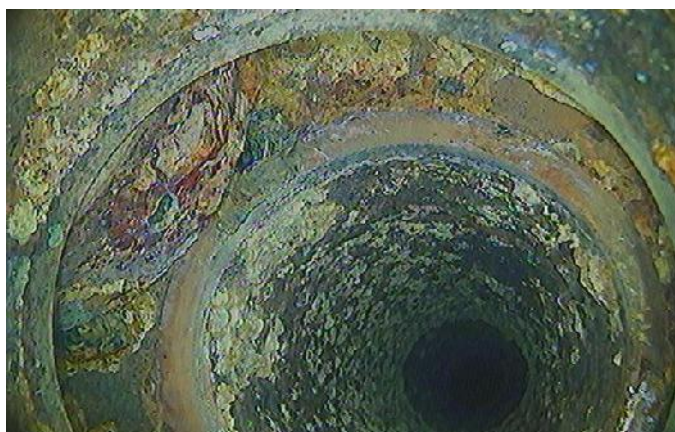
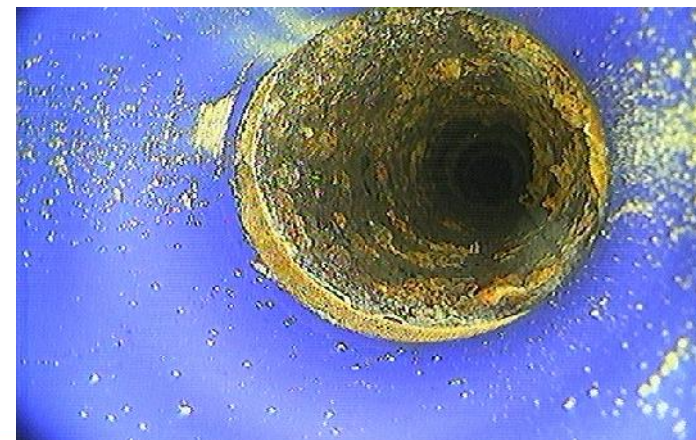
- Valve Corrosion
- Pipe Material Changes
- Identification of unknown assets
- Illegal Connections

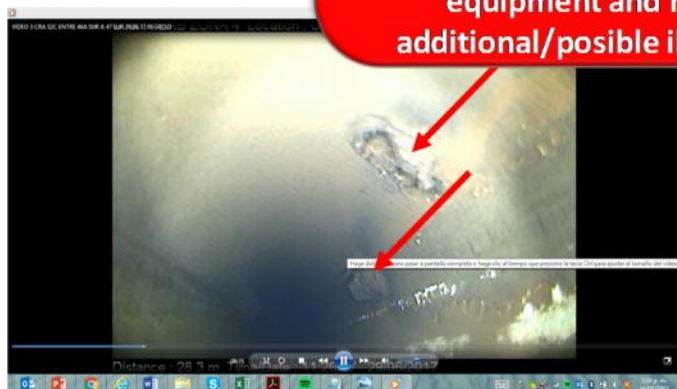
Digging 100% Exactitude After locating equipment and registering an additional/possible illegal connection

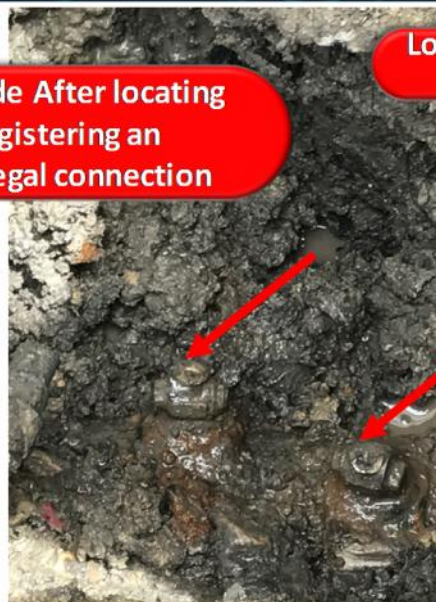
Location of any Observation on the surface. It is Marked

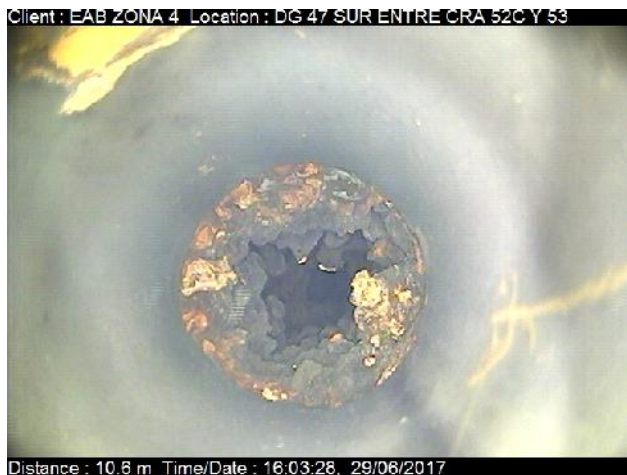
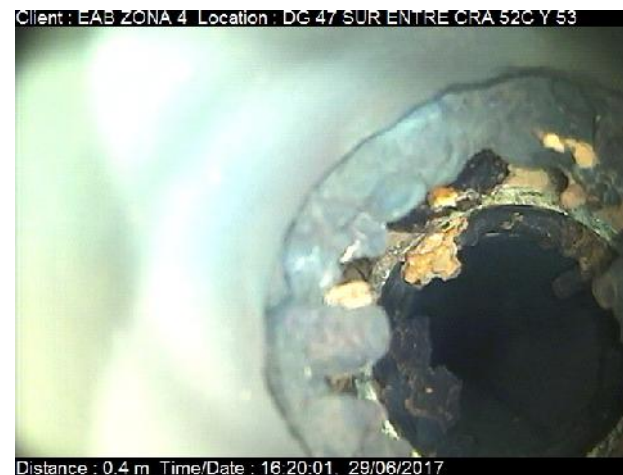
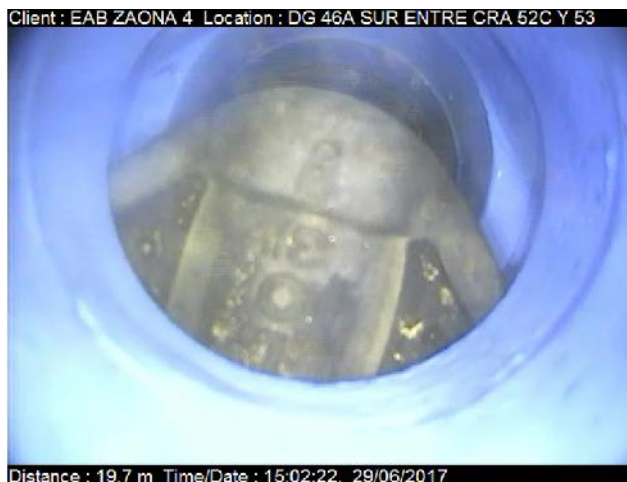
- Valve Corrosion
- Identification of unknown assets
- Condition Assesment

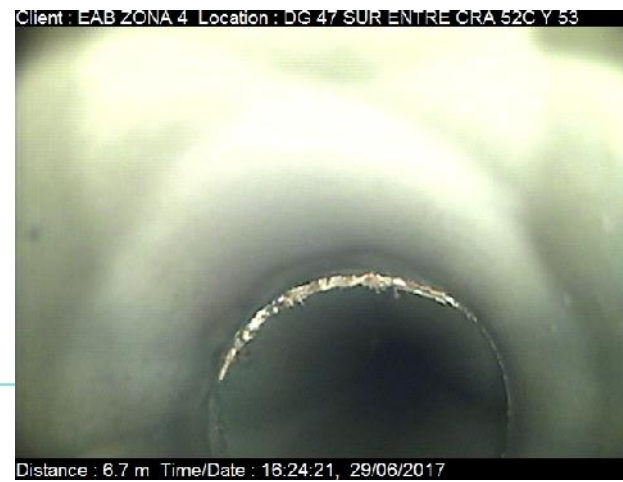
- Valve operation

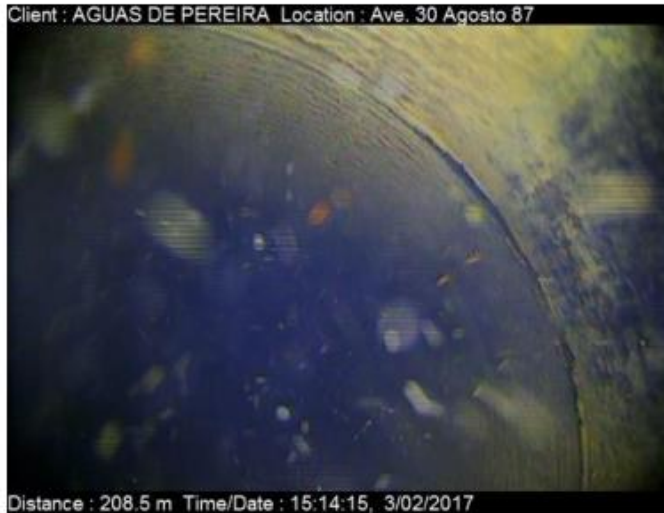
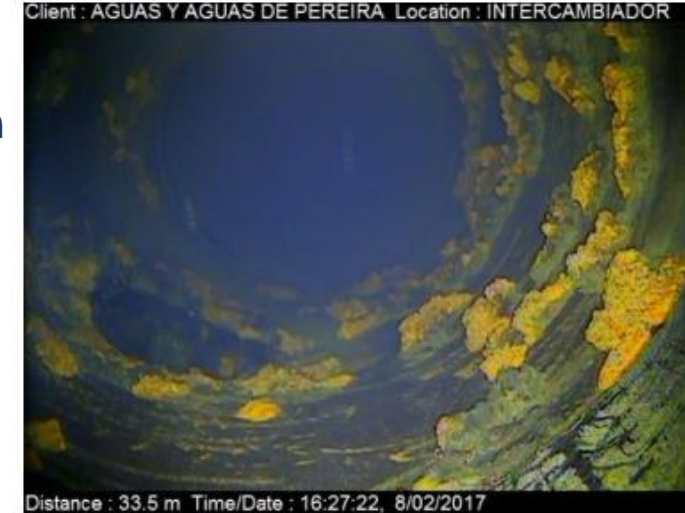
- Joint Condition Verification
- Condition Assessment
- Identification of unknown assets and accesories
- Leaks Were Identified and located

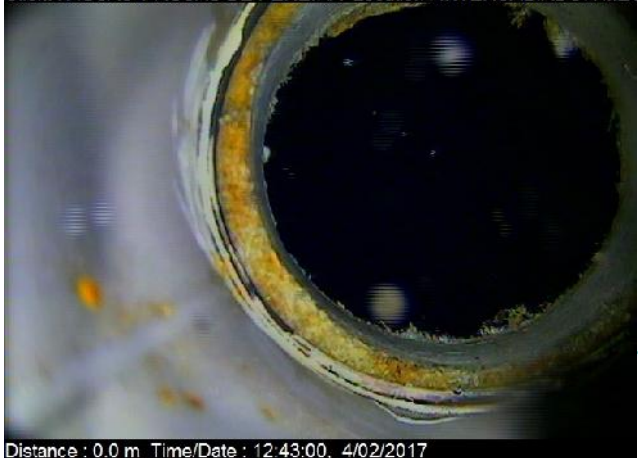
Client : AGUAS Y AGUAS DE PEREIRA Location : INTERCABIADOR MEC

Distance : 0.0 m Time/Date : 12:43:00, 4/02/2017

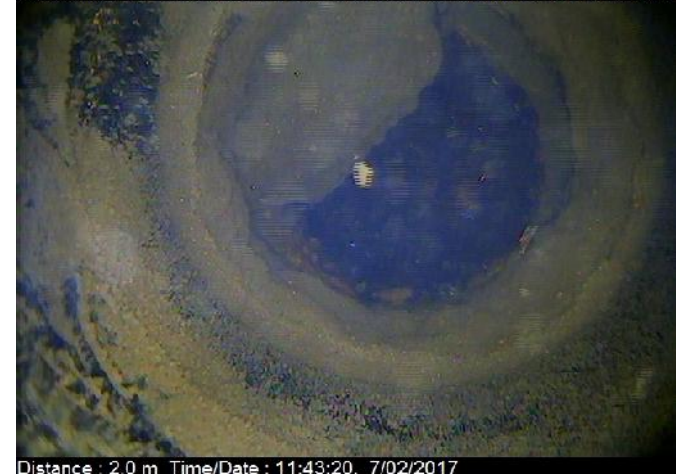
Client : AGUAS Y AGUAS DE PEREIRA Location : TANQUE DE CARGA V

- Valve Corrosion
- Identification of unknown assets
- Condition Assesment
- Valve operation
- Leak Detection

Distance : 2.0 m Time/Date : 11:43:20, 7/02/2017

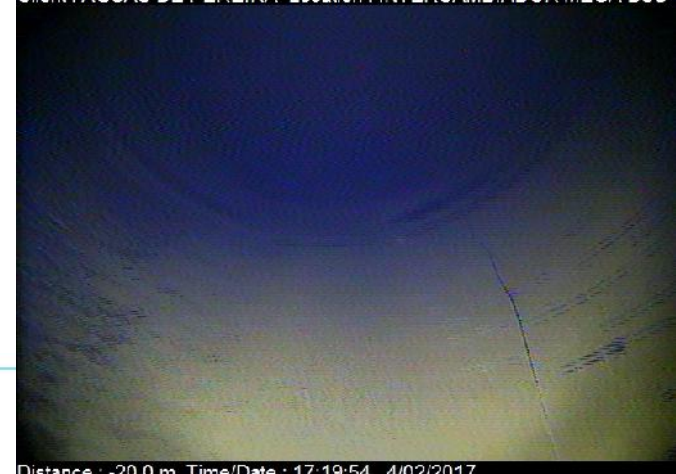
Client : AGUAS DE PEREIRA Location : INTERCABIADOR MEGA BUS

Distance : -20.0 m Time/Date : 17:19:54, 4/02/2017
